IMPACTED TEETH No. 1

This Stereogram gives two views of a mandible. The lower picture shows an impacted lower third molar lying horizontally with its occluding surface resting against the posterior root of the second molar tooth. The upper picture shows the tooth removed, making clear that resorption has taken place, exposing the root canal of the second molar, which more than likely caused pain and eventually the devitalization of the pulp. As the roots of the teeth were pressing in the region of the inferior dental nerve it is possible that the function of the nerve was interfered with, which would cause neuralgia.

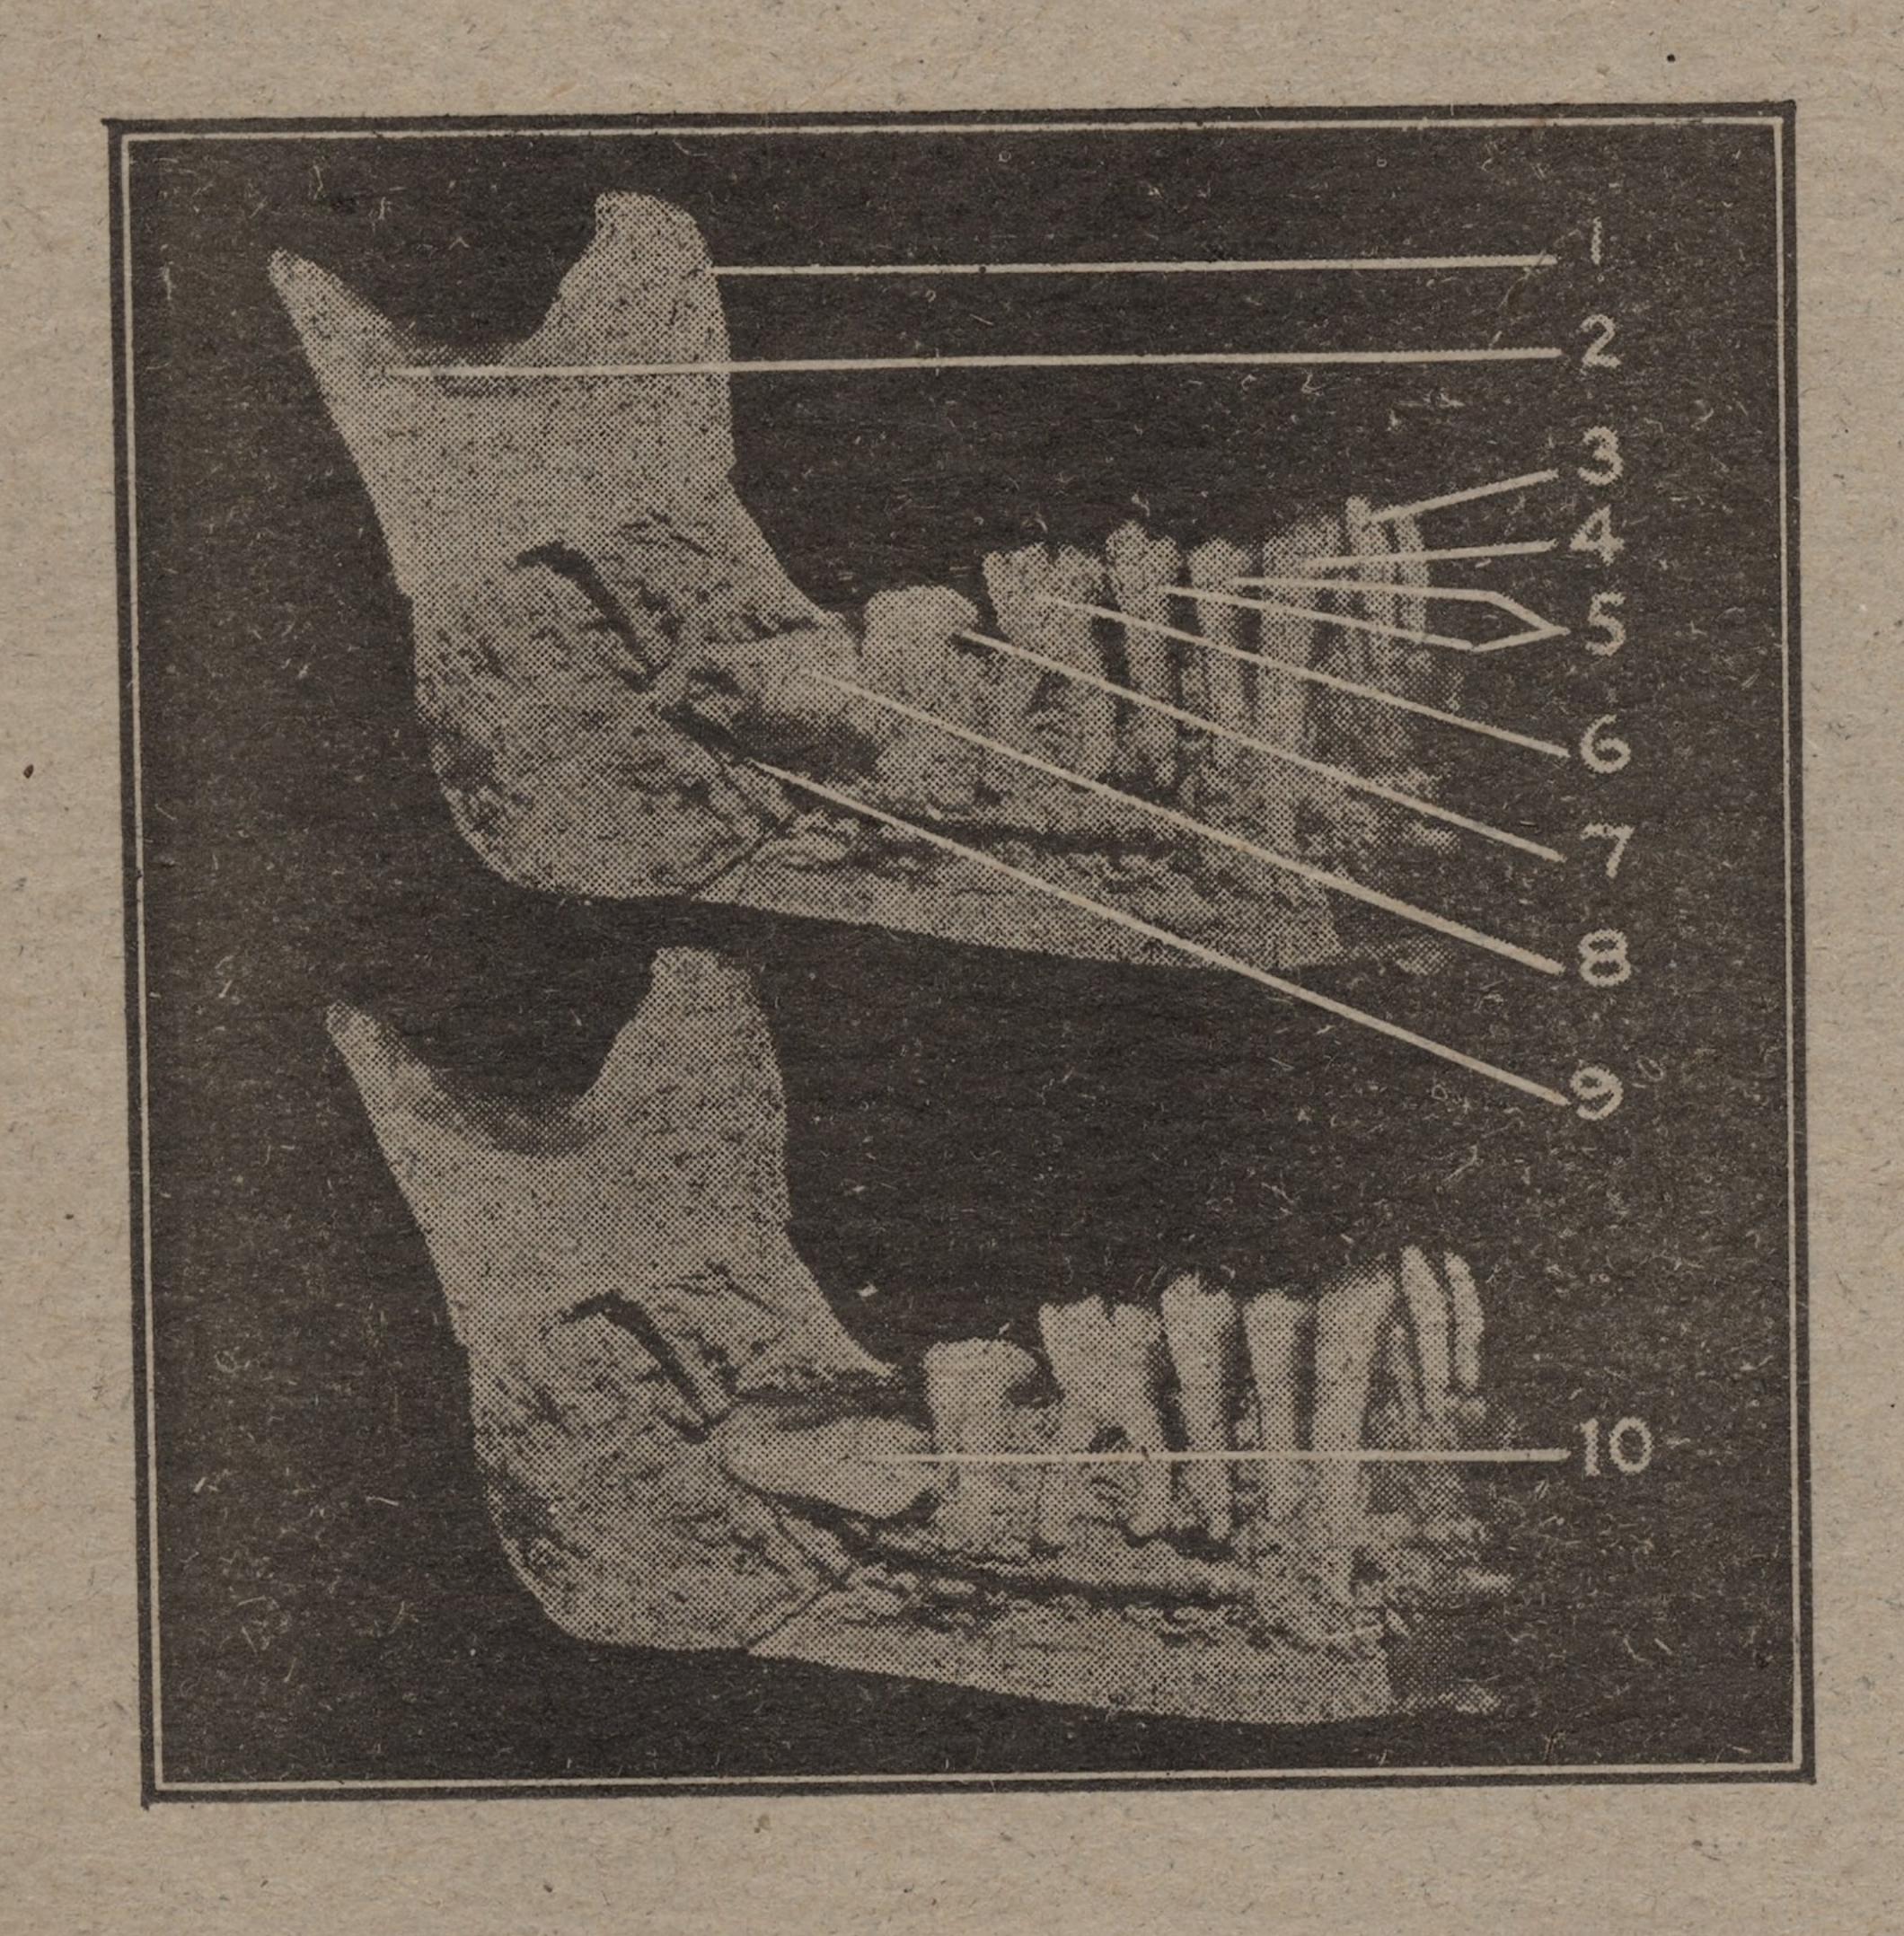
- 1-Coronoid Process
- 2--Condyloid Process
- 3—Incisor Teeth
- 4—Canine Teeth
- 5—Permolar Teeth
- 6-First Molar Teeth
- 7—Second Molar Teeth
- 8—Socket for Impacted Third Molar Tooth
- 9-Inferior Dental Canal
- 10-{ Impacted Third Molar Tooth Replaced in its Socket

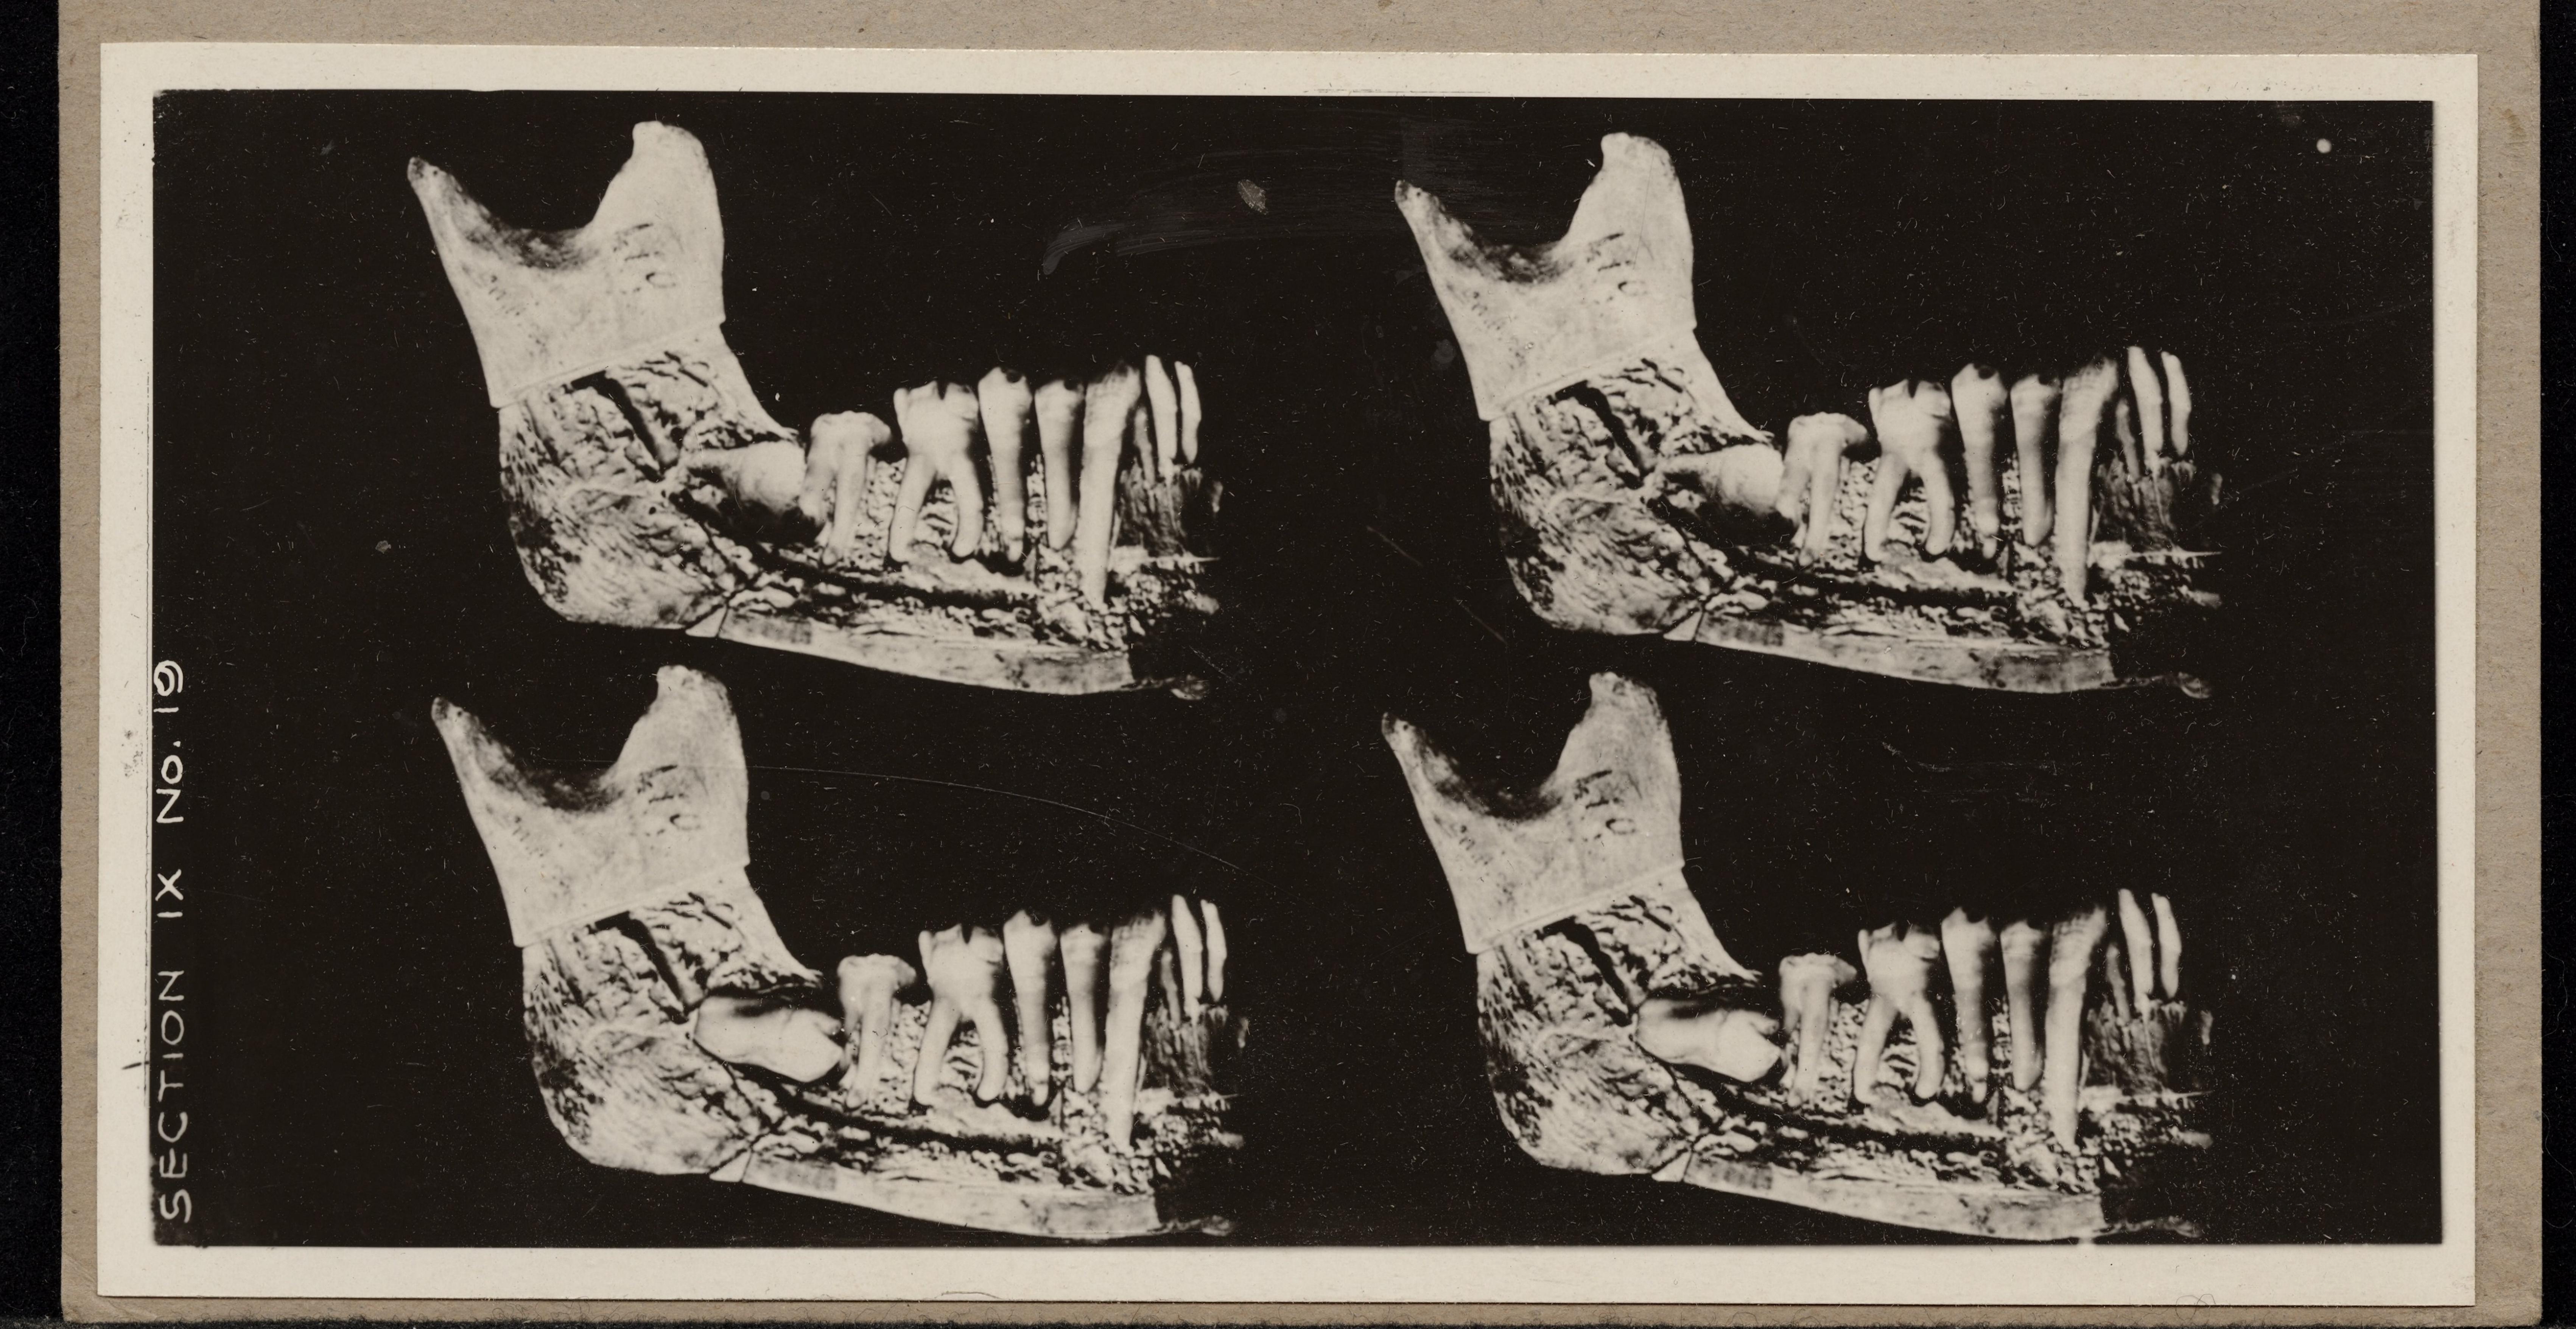
The figures indicate—
