**RANGER (CV)**

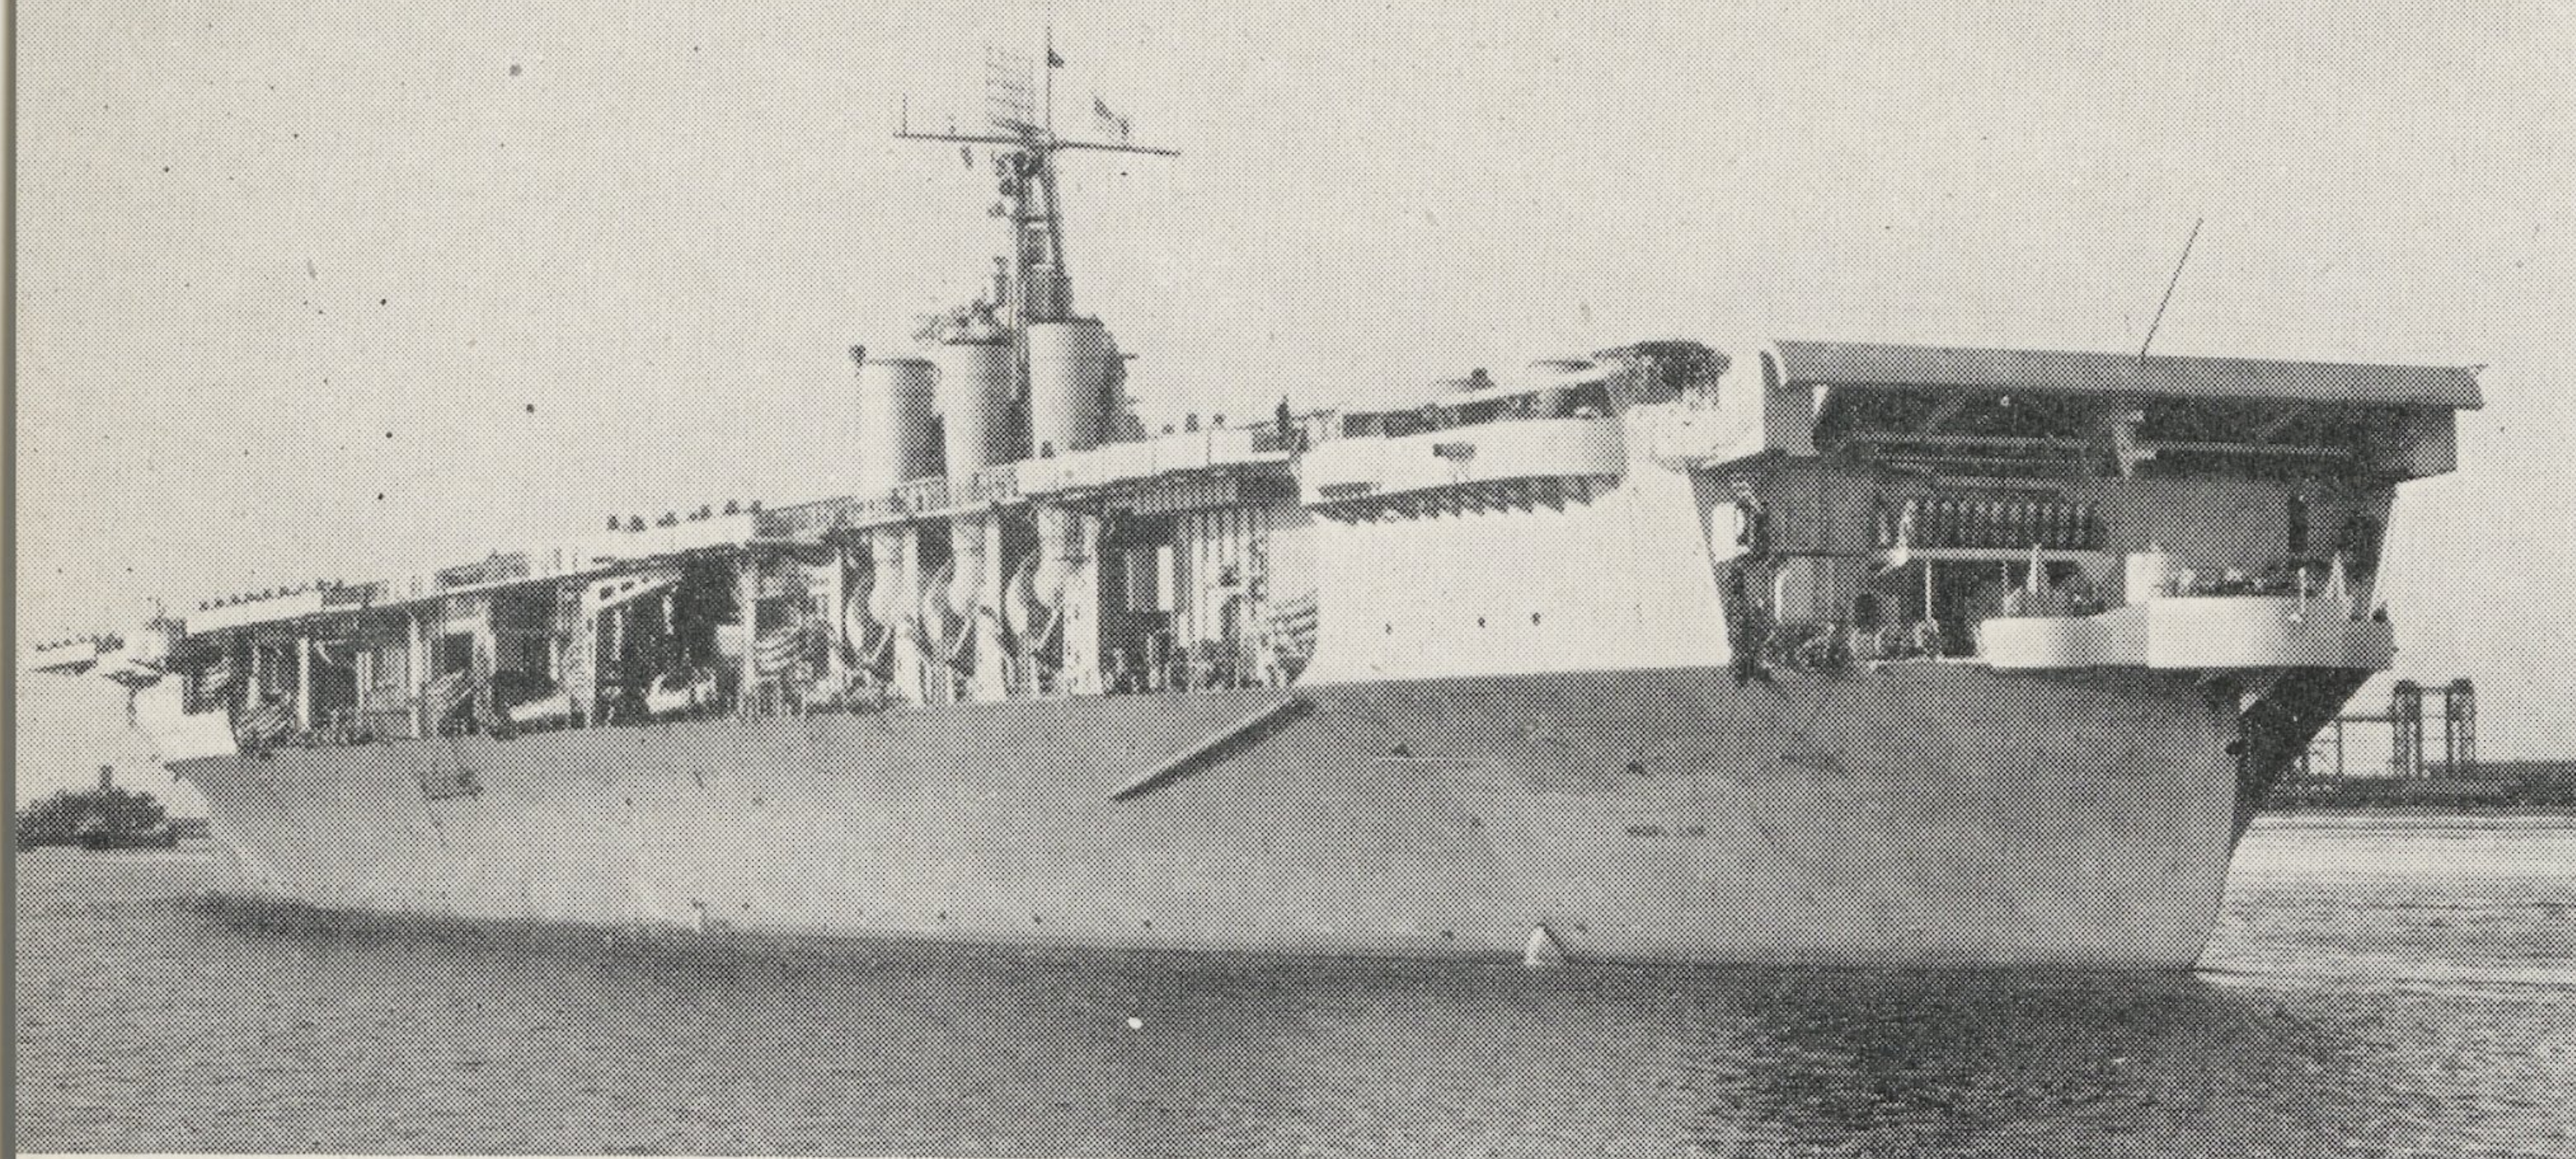
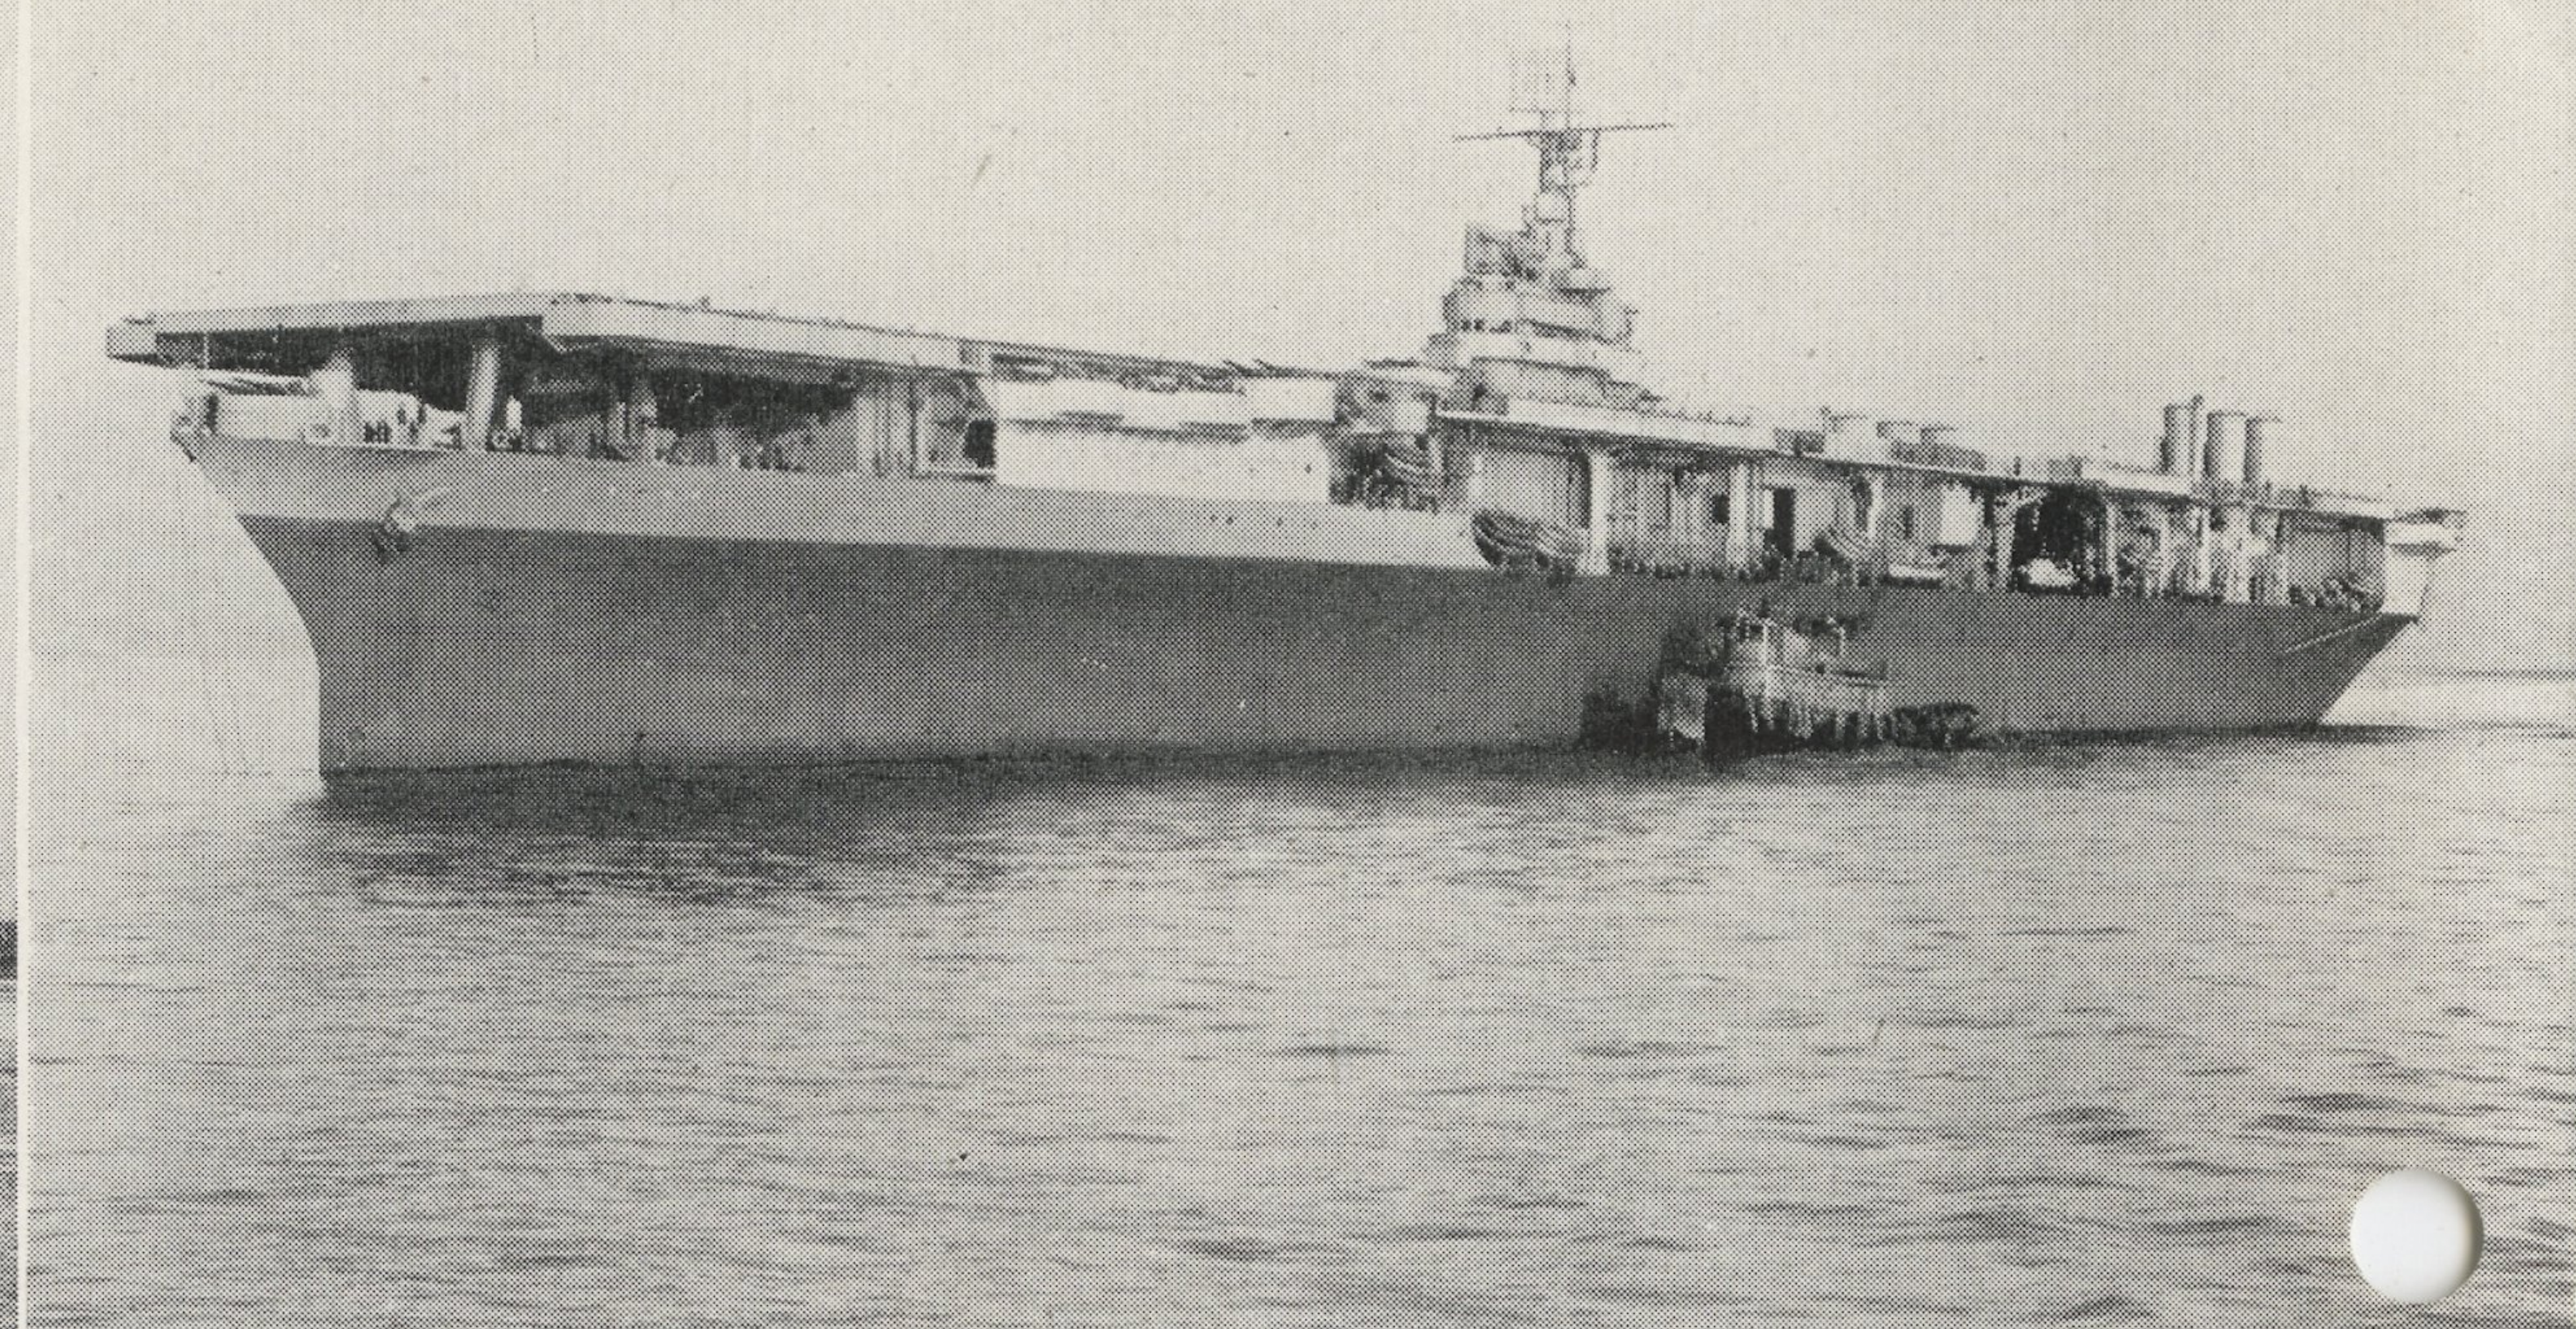
Photos taken 1-6-43. Notice the numerous AAMG positions and open 5-inch gun mounts flanking the flight deck. Also prominent in these views is the characteristic broken freeboard.
